DEPARTMENT OF TRANSPORTATION**DIVISION OF ENGINEERING SERVICES**

Contract #: 04-0120F4Cty: SF/ALA Rte: 80 PM: 13.2/13.9File #: 1.28**WELDING INSPECTION REPORT****Resident Engineer:**Siegenthaler, Peter**Address:** 333 Burma Road**City:** Oakland, CA 94607**Report No:** WIR-017221**Date Inspected:** 30-Sep-2010**Project Name:** SAS Superstructure**OSM Arrival Time:** 630**Prime Contractor:** American Bridge/Fluor Enterprises, a JV**OSM Departure Time:** 1500**Contractor:** American Bridge/Fluor Enterprises, a JV**Location:** Job Site**CWI Name:** See below**CWI Present:** Yes No**Inspected CWI report:** Yes No N/A**Rod Oven in Use:** Yes No N/A**Electrode to specification:** Yes No N/A**Weld Procedures Followed:** Yes No N/A**Qualified Welders:** Yes No N/A**Verified Joint Fit-up:** Yes No N/A**Approved Drawings:** Yes No N/A**Approved WPS:** Yes No N/A**Delayed / Cancelled:** Yes No N/A**Bridge No:** 34-0006**Component:** SAS OBG**Summary of Items Observed:**

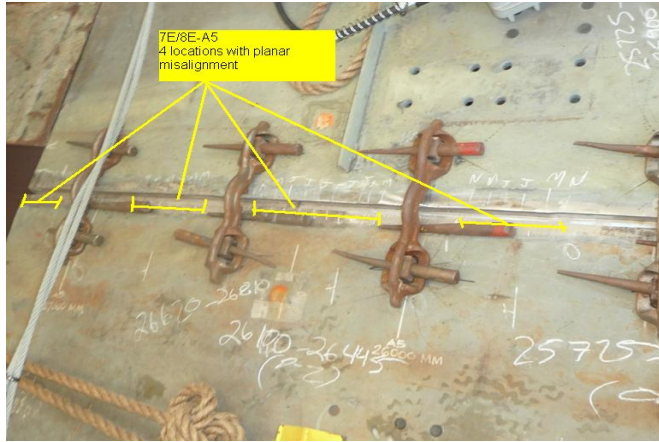
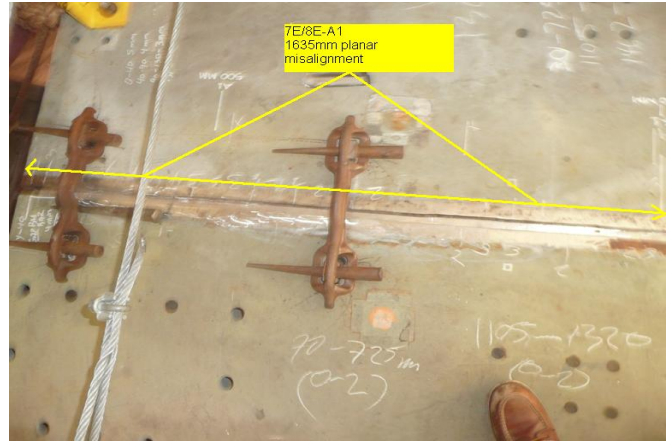
7E/8E-A1-A5

Upon the arrival of the QA Inspector in the am it was observed the above identified weld joint was fit up with the approved temporary attachments or fit up gear in place. Upon the arrival of the QA Inspector, the QC Inspector Tony Sherwood informed the QA Inspector the planar misalignment inspection had been previously performed by SE QC and just required QA verification. The QC Inspector presented the QA Inspector with a planar misalignment map of the areas previously located by QC Tony Sherwood. The QA inspector noted the map indicated the only planar off set was located in the weld segment A1 and totaled 130mm. The QA Inspector reviewed the document and proceeded to perform the random QA verification of the weld joint. The QA Inspector observed approximately 2000mm in addition to what was previously located by the QC Inspector. It appeared the fit up gear had broken in weld segment A5 and the plates had shifted out of the previous position. The QA Inspector asked the ABF Welding Superintendent Dan Ieraci if he intended to correct the unacceptable planar misalignment (see summary of conversations). The QA Inspector randomly observed Mr. Ieraci and ABF welder James Zhen make several attempts to correct the off set areas by re-welding the broken fit up gear and driving additional pins to push one side of the deck downward. After several attempts it was observed by the QA Inspector no change in the unacceptable planar off set. The QA Inspector and the QC Inspector recorded the following locations of planar misalignment:

The unacceptable planar misalignment was located at the following 5 locations:

- 1.) y=0mm-1635mm (20mm deck section) 0mm-2mm misalignment (1635mm in length)
- 2.) y=25710mm-25915mm (20mm deck section) 0mm-2mm misalignment (205mm in length)
- 3.) y=26090mm-26345mm (20mm deck section) 0mm-2mm misalignment (255mm in length)
- 4.) y=26625mm-26855mm (20mm deck section) 0mm-2mm misalignment (230mm in length)
- 5.) y=27120mm-27280mm (20mm deck section) 0mm-2mm misalignment (160mm in length)

Total planar misalignment 2485mm of the total length of the weld joint.

The QA Inspector and the SE QC Inspector Tony Sherwood performed dimensional verification of the gaps at the steel backing. The QA Inspector noted the 11 separate areas where the gap at the steel backing exceeded 2mm. The QA Inspector noted the largest gap was 3mm and no gap exceeded 3mm for the above identified transverse weld splice. The QA Inspector was informed by these Lead QC Leonard Cross the contractor will write and submit an internal non conformance report in addition to a request to weld repair over the excessive gaps at the steel backing.

The QA Inspector noted the above identified locations will require engineering approval prior to performing any weld repairs. The QA Inspector noted the locations were submitted by SE to ABF and the approval was given by the Project Engineer Patrick Lowry (see summary of conversation)
